OHIO RIVER BASIN
McCUNE RUN, WESTMORELAND COUNTY
PENNSYLVANIA

NDI No. Pa. - 480
KEYSTONE DAM

PHASE I INSPECTION REPORT
NATIONAL DAM INSPECTION PROGRAM

GAI CONSULTANTS, INC.
570 BEATTY ROAD
MONROEVILLE, PENNSYLVANIA 15146

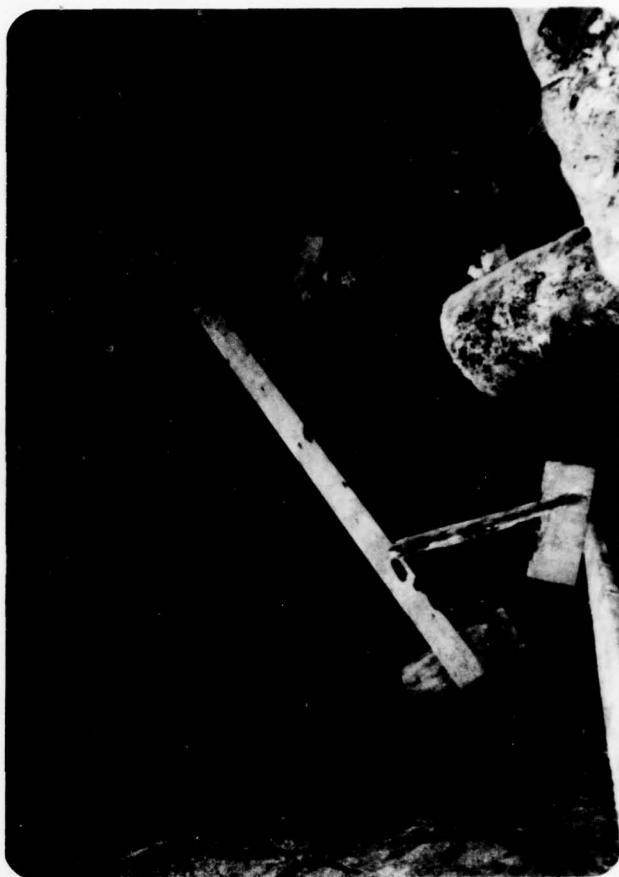
The valve house is in a serious state of disrepair. The building needs repointed, some masonry reset, doors and locks installed. Furthermore, a safe access for operating personnel should be provided. Discussion with PennDER officials indicate that rehabilitation and/or replacement of the valve house is a priority project.

PHOTOGRAPH 8

Detailed view showing the interior of the valve house.
